THE SIDE MIRRORS, AS IF SUSPENDED IN MID-AIR, THANKS TO THE AIRFOIL-SHAPED SUPPORT ARE SET APART FROM THE BODY FOR BETTER AERODYNAMIC PENETRATION, SHOWING THE METICULOUS OPTIMIZATION THAT WAS CARRIED OUT ON THEM IN THE WIND TUNNEL.

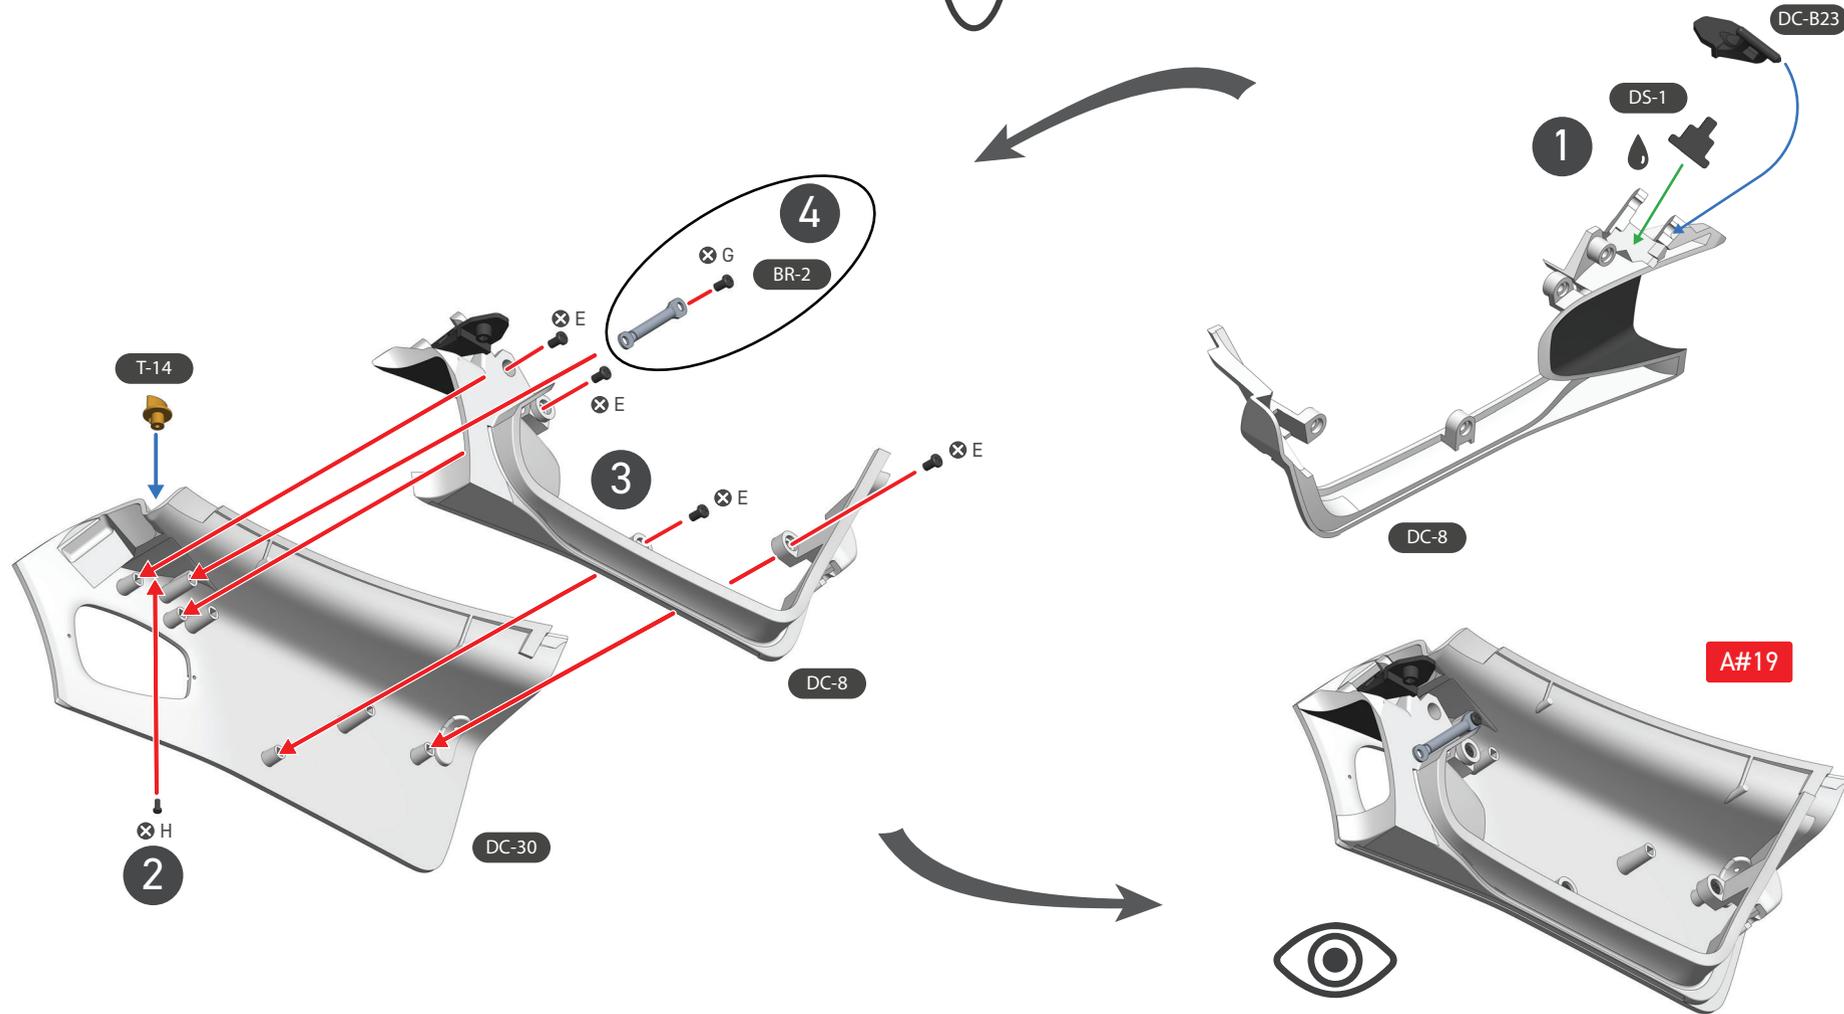
A#19

Ensure DS-1 is positioned correctly and verify that DC-B23/24 is installed on the appropriate side of the vehicle.

SCREW E = 4  
SCREW G = 1  
SCREW H = 1

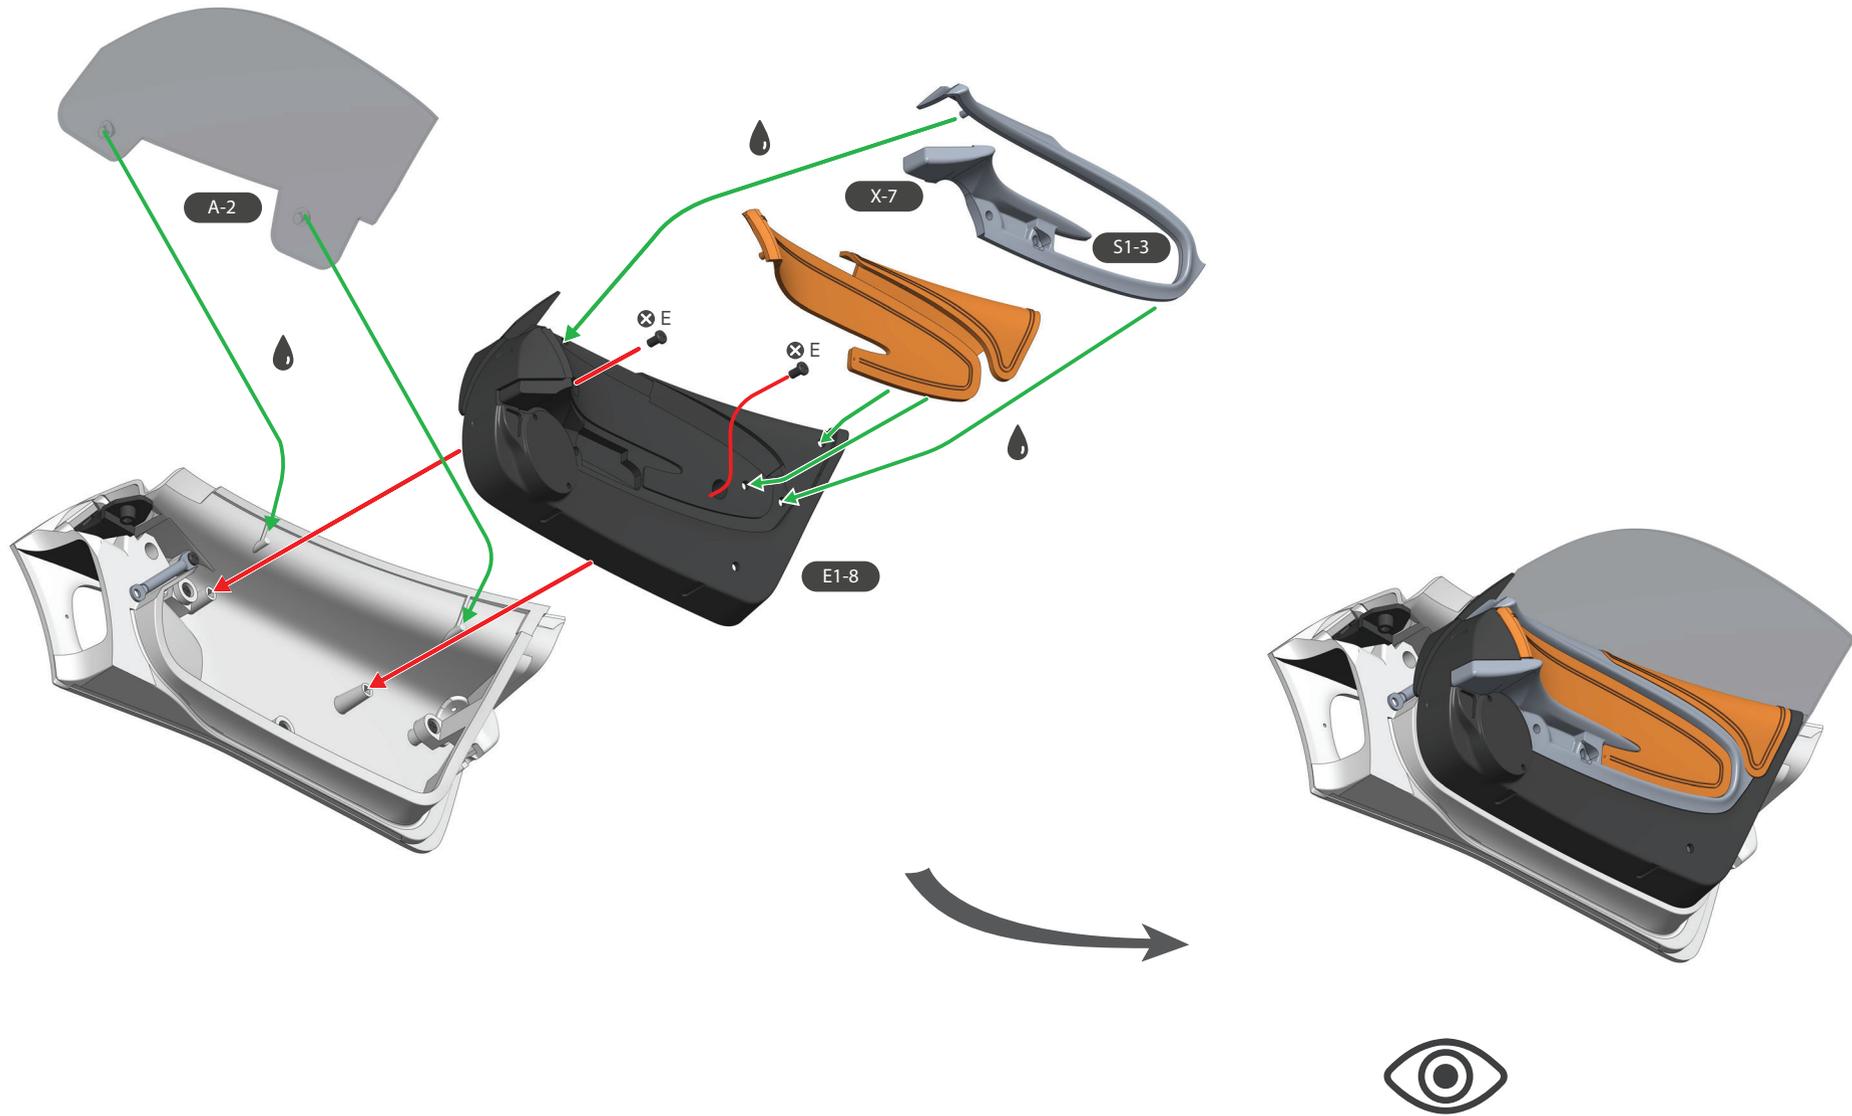
SCREW E = 2

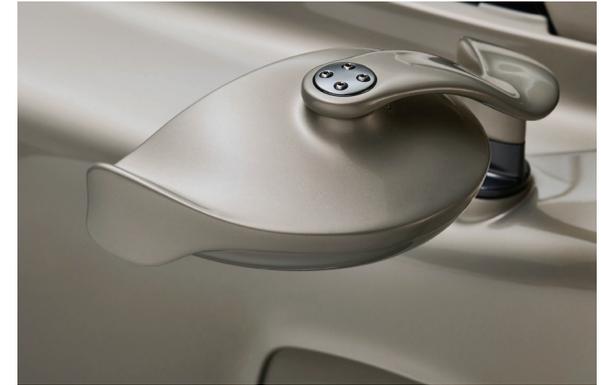
SCREW Q = 1

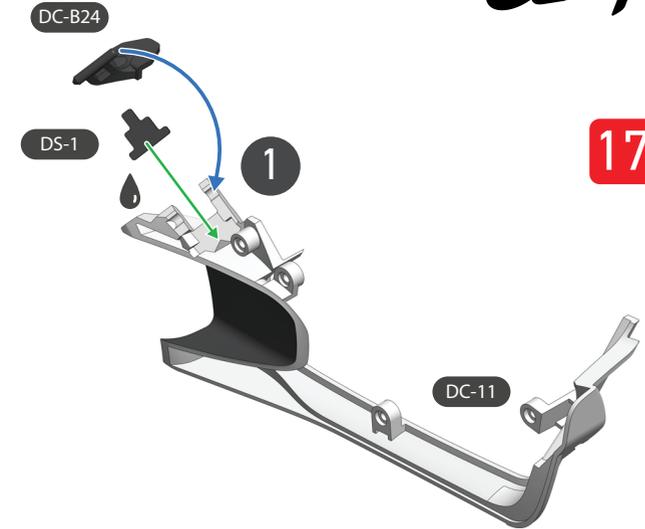
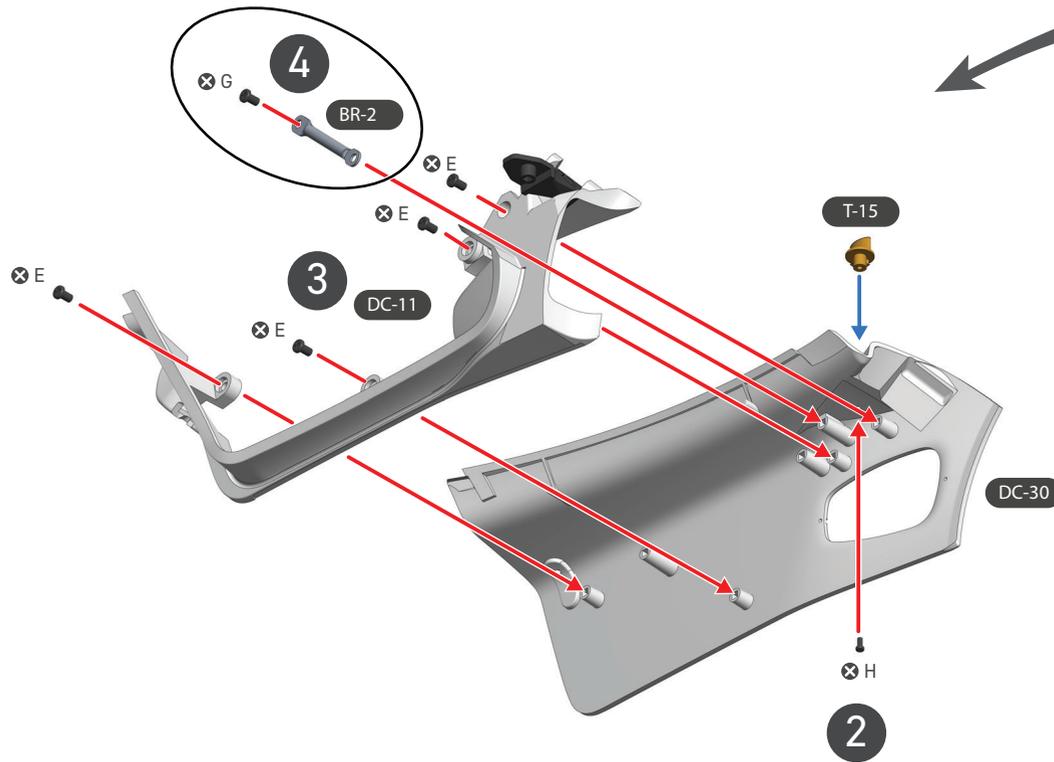
A#20

Ensure DS-1 is positioned correctly and verify that DC-B23/24 is installed on the appropriate side of the vehicle.

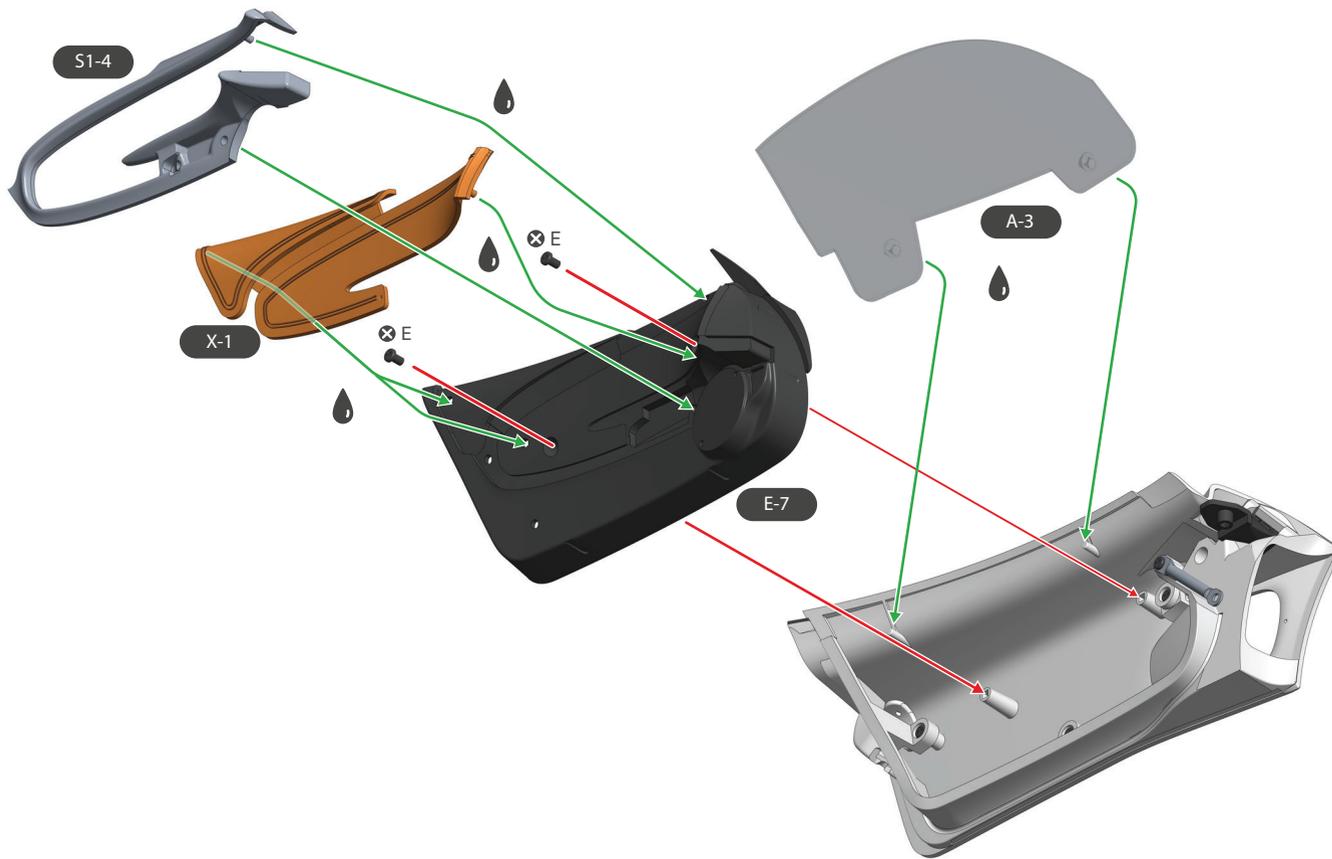
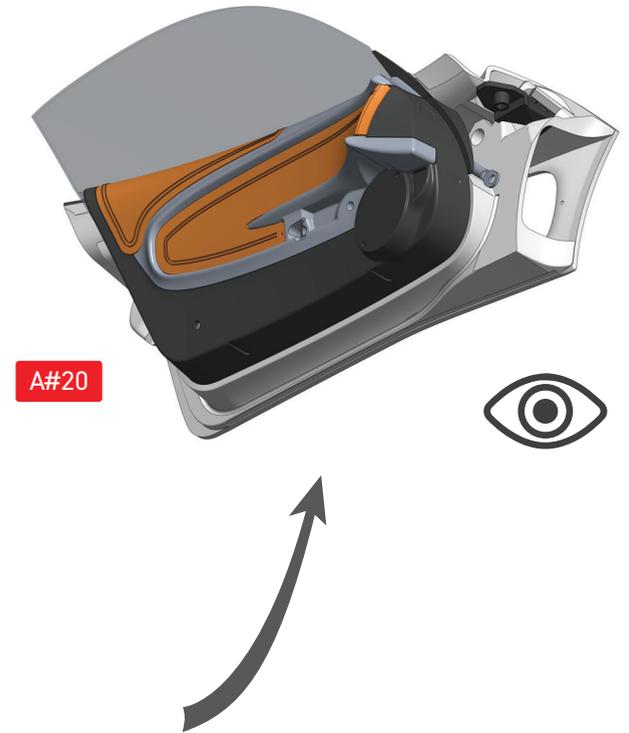
SCREW E = 4  
SCREW G = 1  
SCREW H = 1

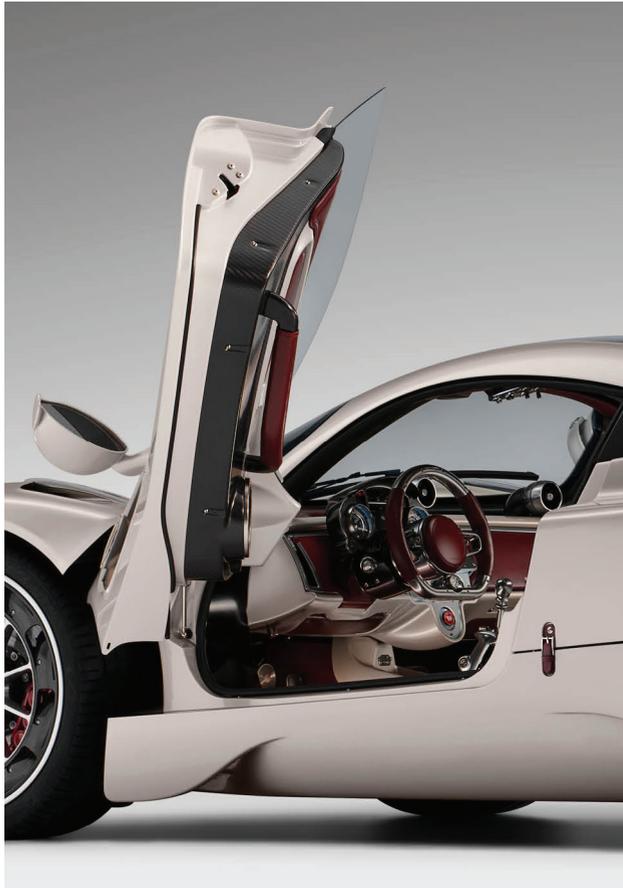
SCREW E = 2

THE PAGANI UTOPIA'S BUTTERFLY DOORS SWING UPWARD AND OUTWARD, COMBINING STYLE AND EASE OF ACCESS. OPERATED BY FINGER LATCHES, THEY EMBODY PAGANI'S SEAMLESS BLEND OF ELEGANCE AND FUNCTIONALITY.

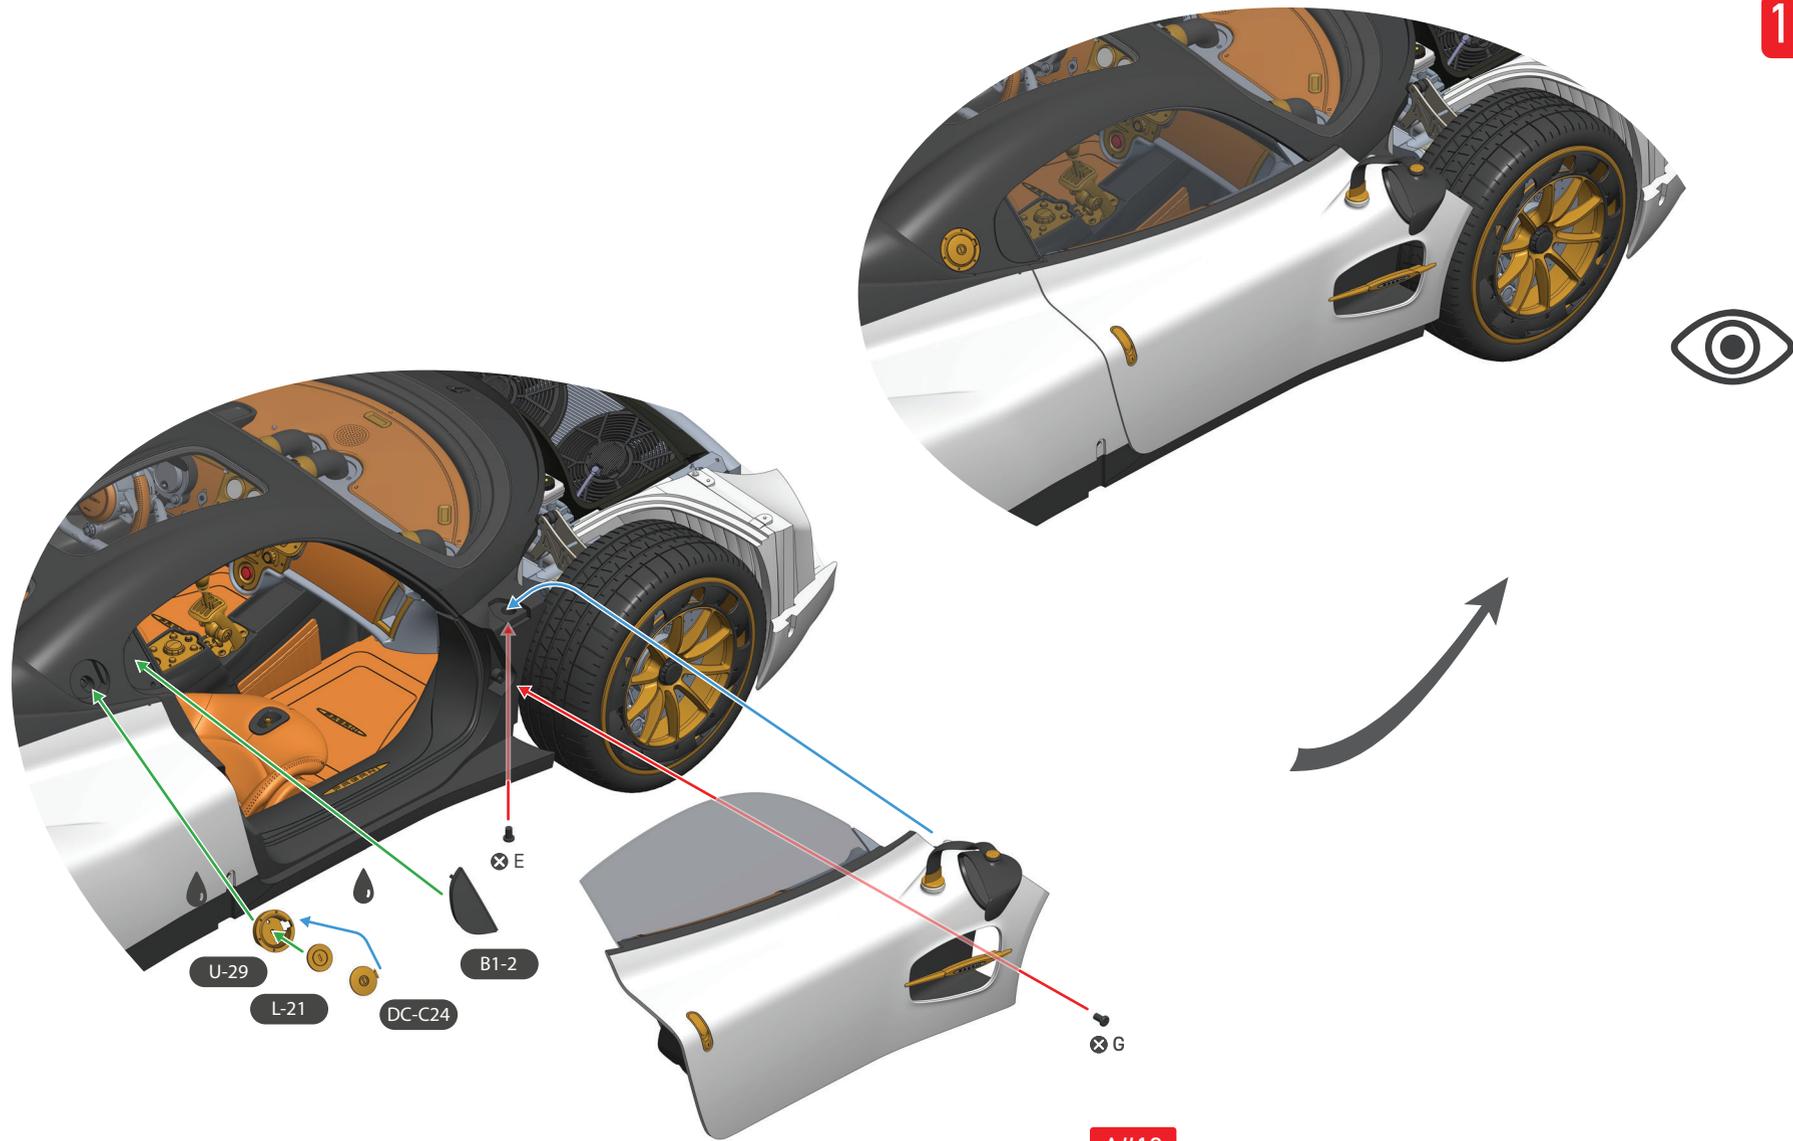
A#19

SCREW E = 1  
SCREW G = 1

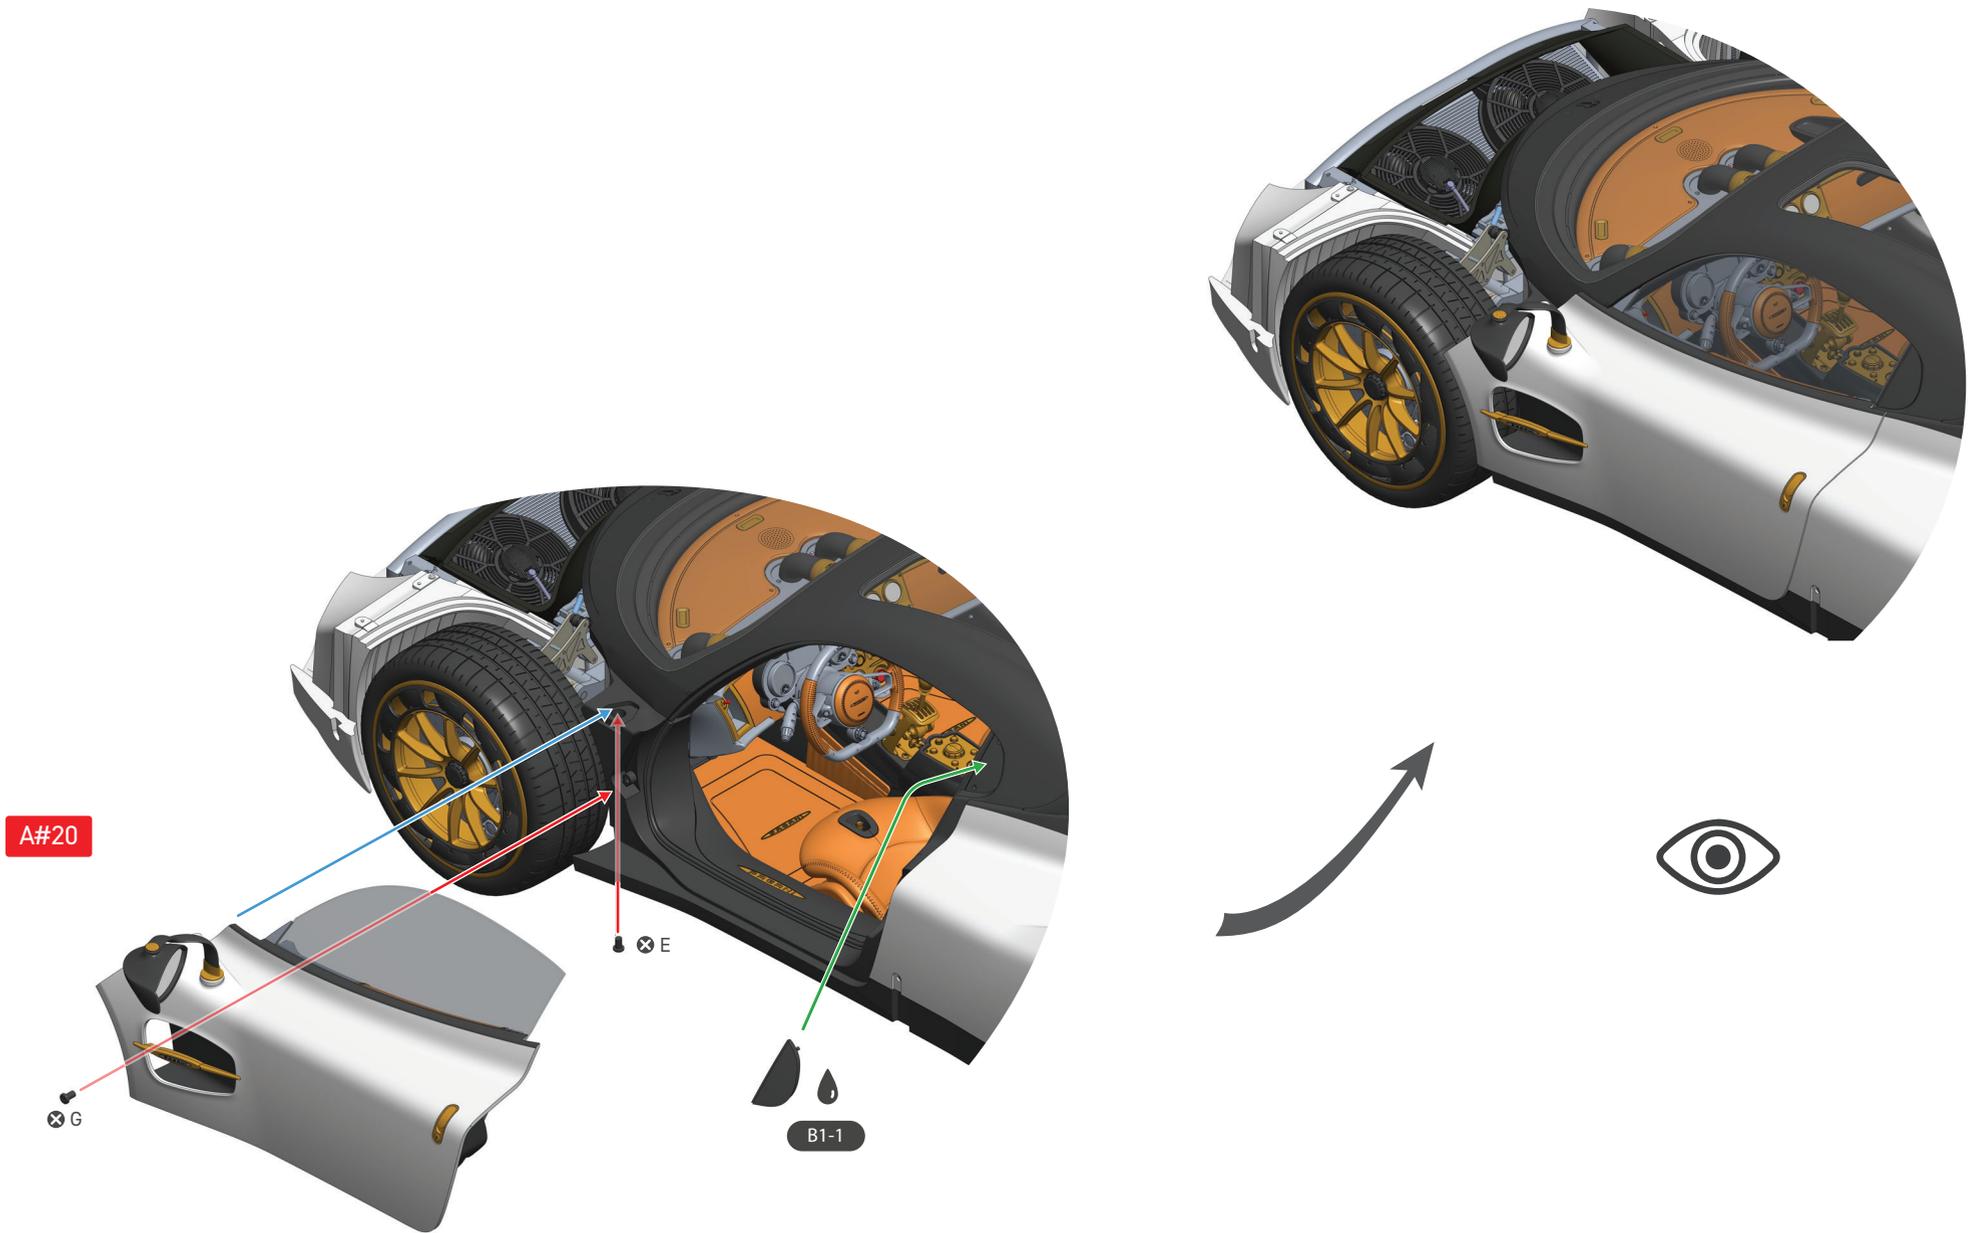
SCREW E = 1  
SCREW G = 1

Improper alignment of components beneath the hood or incorrect fastening of E screws (see page 37) may result in visible panel gaps.

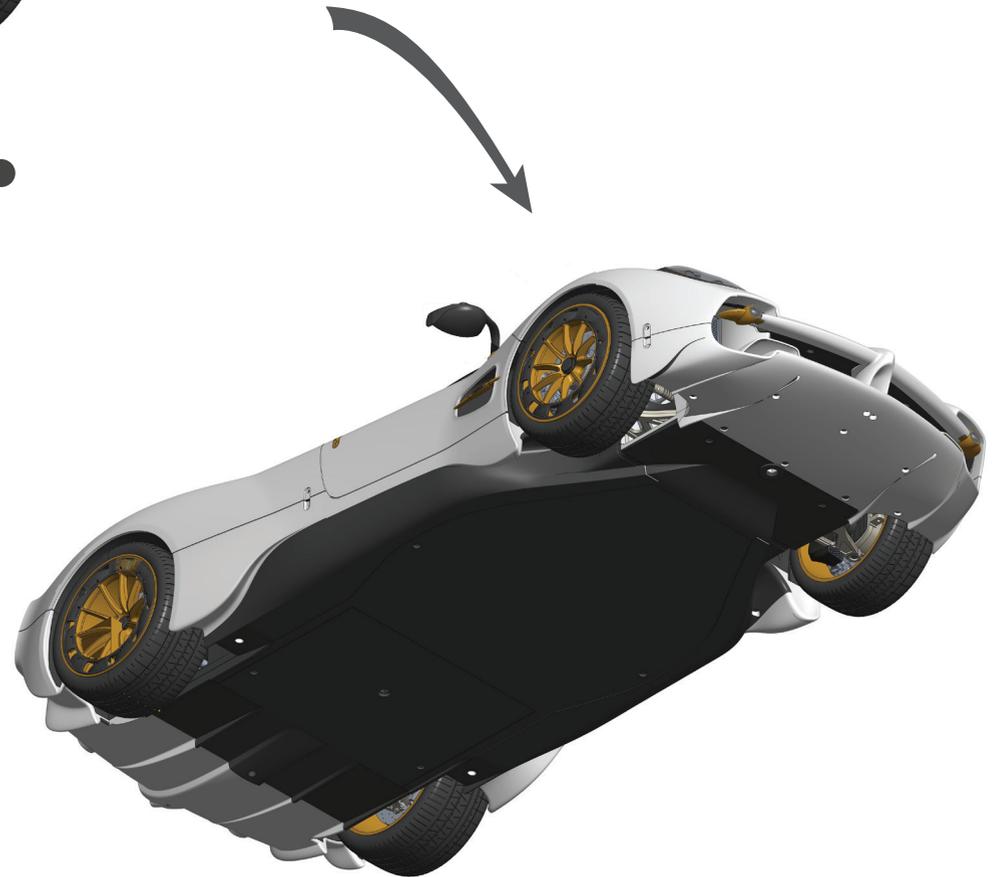
A#1

SCREW C = 2  
SCREW E = 11
